## MEMORANDUM

**SUBJECT:** Summary of March 17, 2026, Arborist Site Walk and Recommendations for Protection of Street Trees for 19th Street Reconstruction Project in Upland, California (LSA Project No. 20262811)

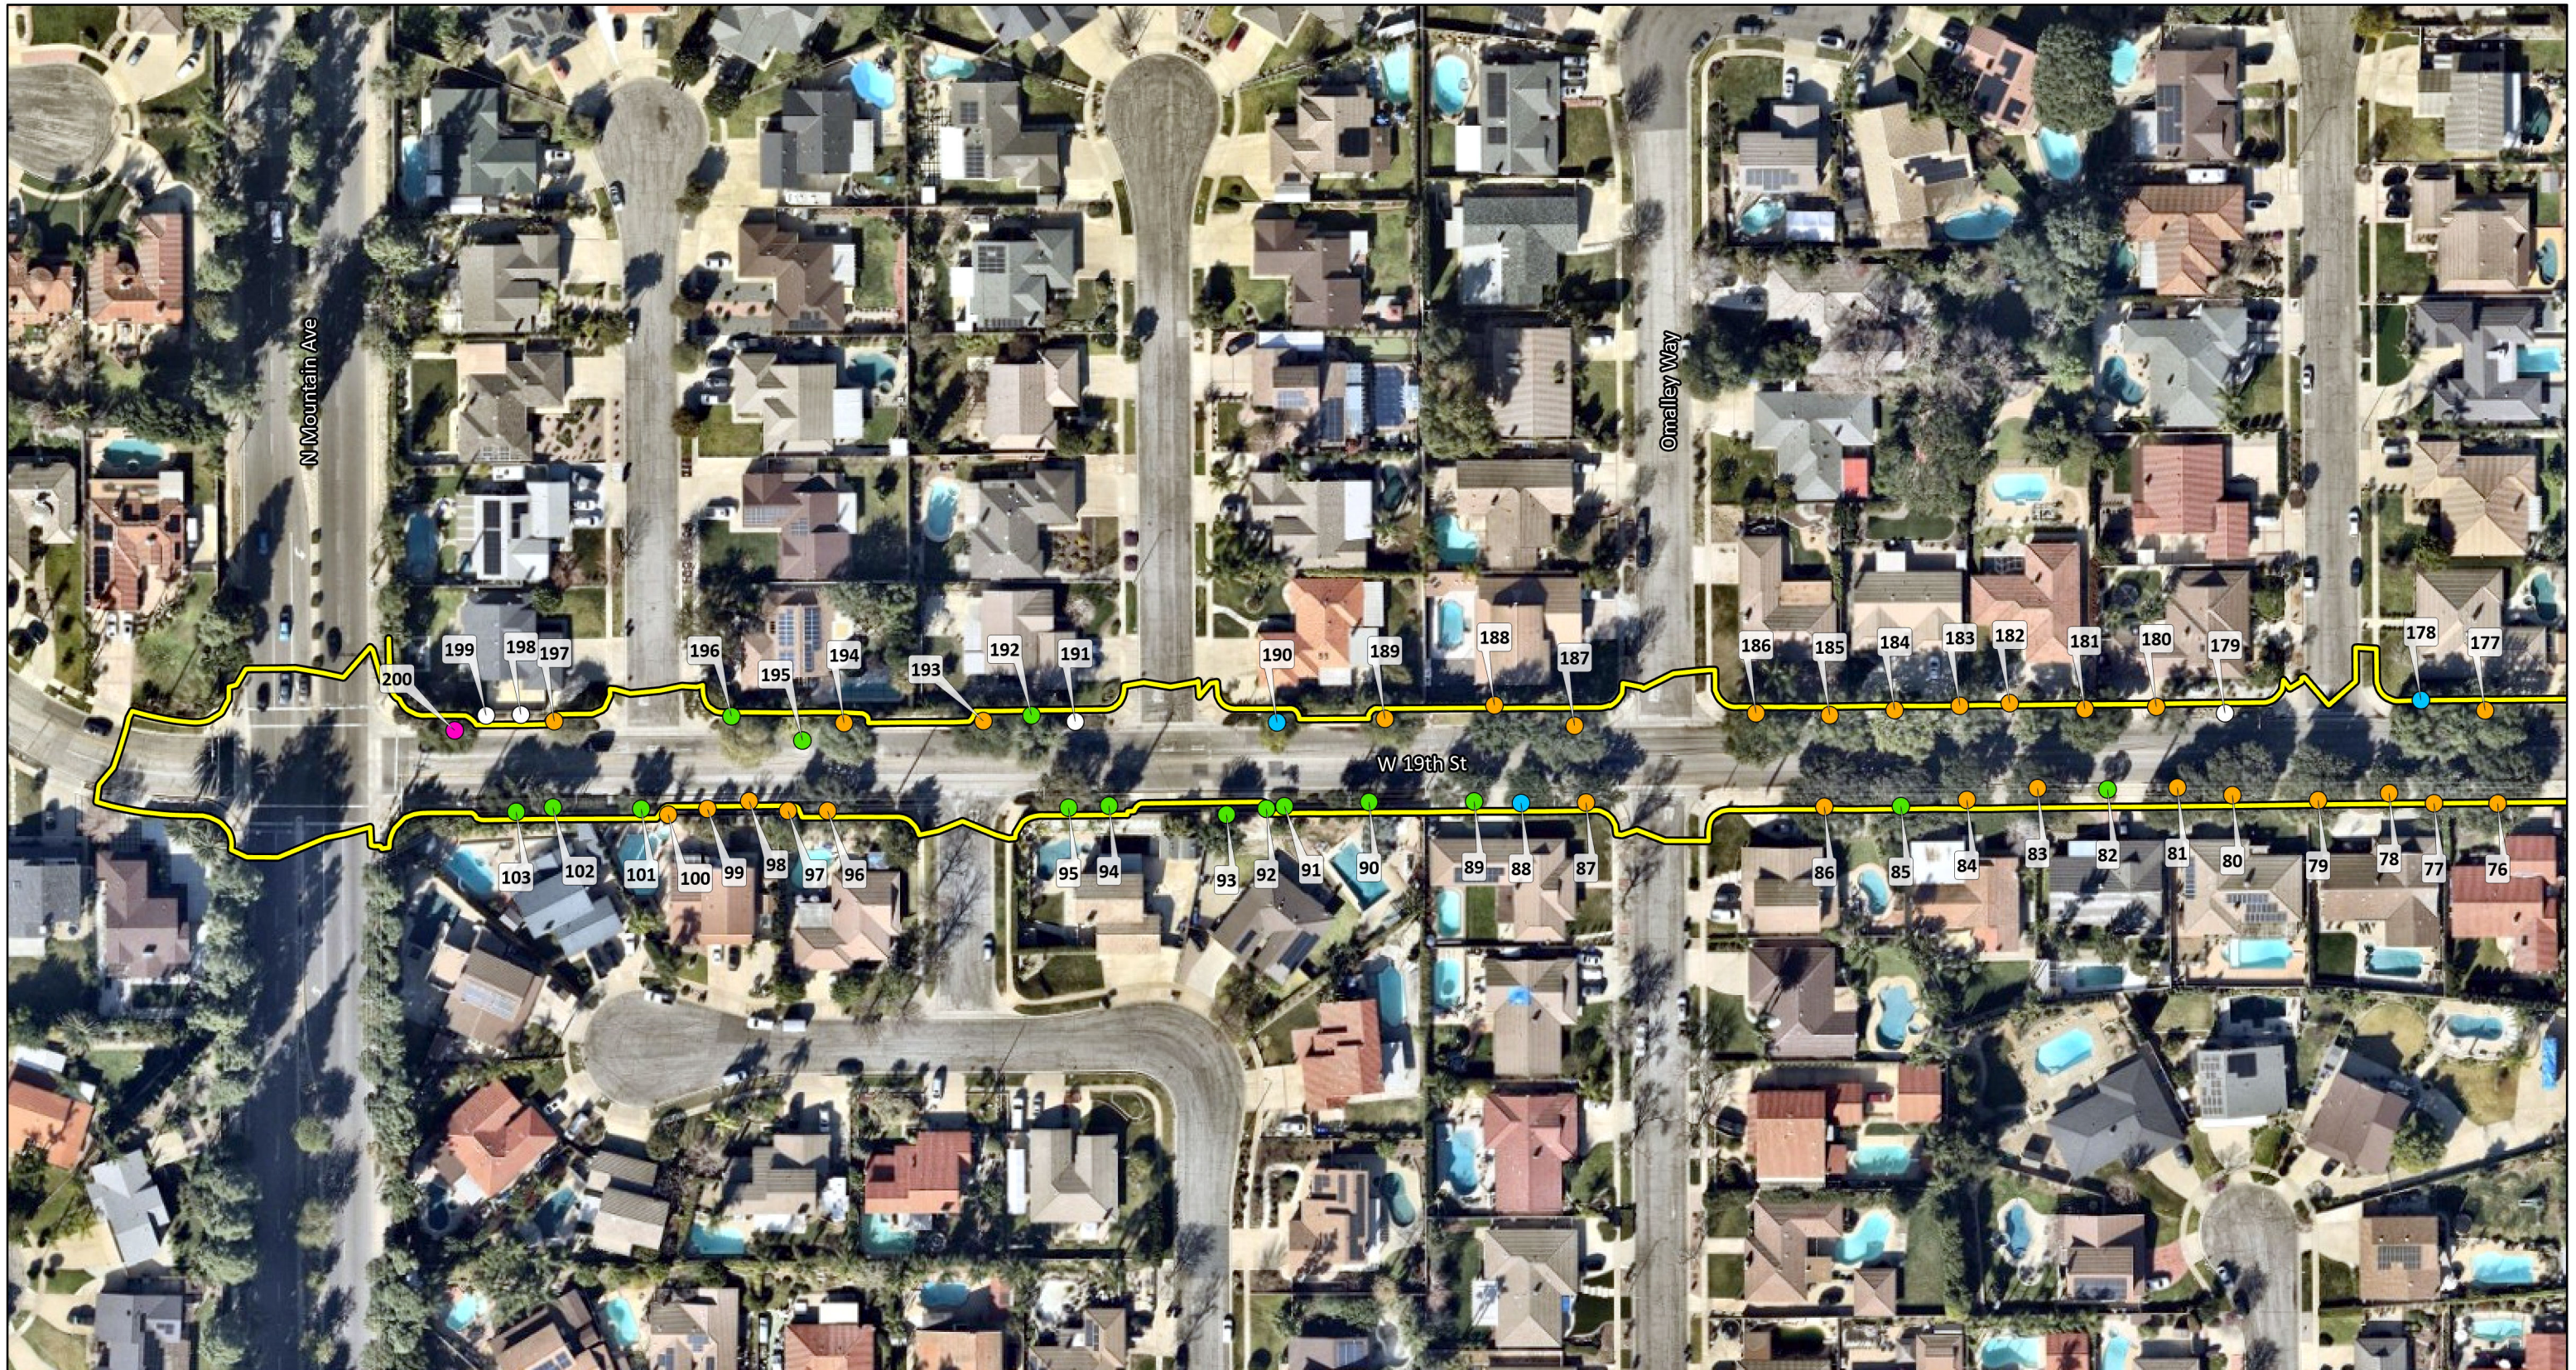
FIGURE 1  
Sheet 1 of 4

The City provided geographic information system (GIS) mapping of 200 street trees on and adjacent to the project site. To this, Dr. Spencer added two trees (Trees 201 and 202) that did not appear in the City's GIS data. All 202 trees are shown in Figure 1, identified with numbers assigned by LSA. Table A (attached) provides corresponding tree identification numbers from the City's GIS database, species identifications, and recommendations for minimization of impacts to each tree.

The damage to sidewalks and curbs requiring repair was caused by large roots lifting these structures. These roots, given their size, are likely to be critical to the health and, in many cases, to the stability of the trees. Municipal Code Section 12.26.080 states that, if the repair of sidewalks, curbs, or other infrastructure would create a need to prune critical roots, consideration should be given to alternative actions (such as raising or displacing a sidewalk) to prevent damage to the health or stability of a tree or need for its removal. Such alternatives were considered for each tree. These alternatives, where feasible, are indicated in Table A. Otherwise, tree removal and replacement with a more suitable species is indicated. The trees were divided into 5 groups (A through D) as shown in Figure 1 and indicated in Table A.
